CONNECTICUT RIVER BASIN  
SOUTHWICK, MASSACHUSETTS

CONGAMOND LAKES OUTLET  
(MIDDLE POND)  
MA 00071

PHASE I INSPECTION REPORT  
NATIONAL DAM INSPECTION PROGRAM

MARCH 1979

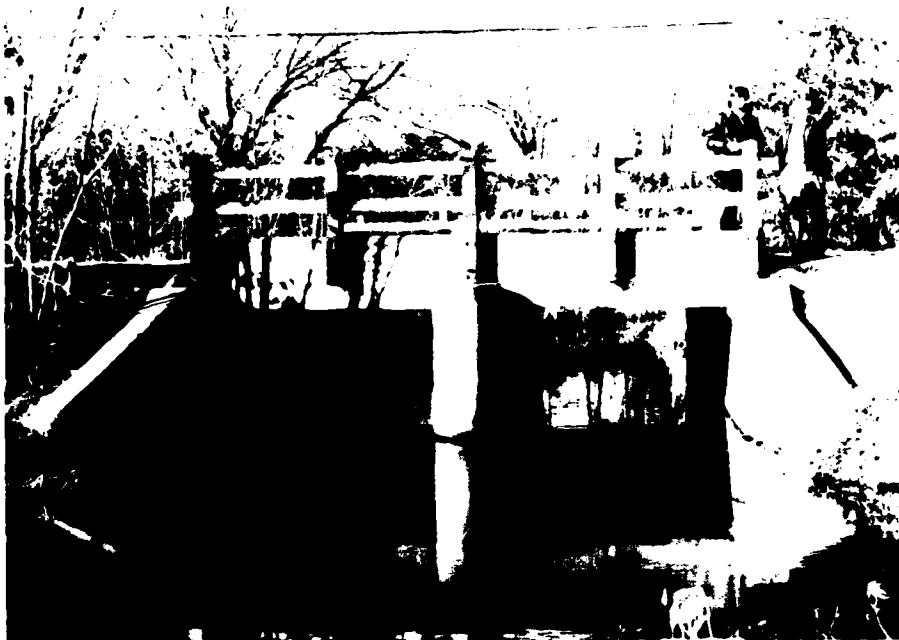
The abutment walls of the outlet structure are in good condition. Visual inspection showed the twin concrete box culvert to be in excellent condition. There were no cracks, no spalling, and good alignment. All expansion joints at the wingwalls also showed good alignment.

PHOTO NO. 3 - Outlet structure.

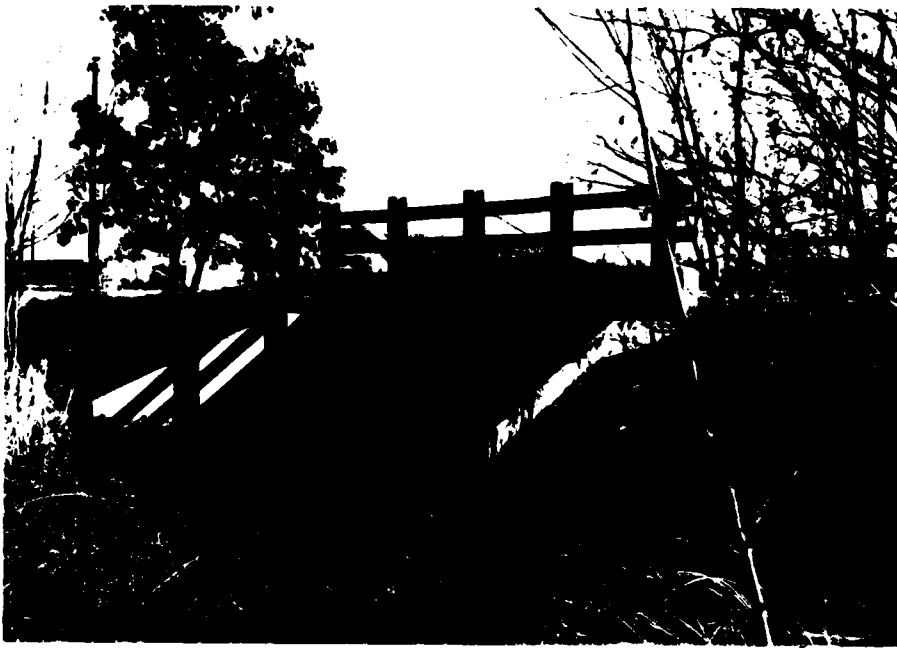
PHOTO NO. 9 - View of downstream face of structure.
